Safety Awareness Topic of the Month

Fire Safety

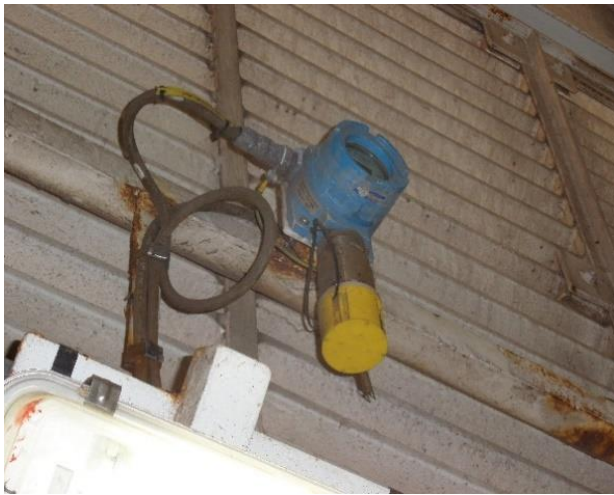
Figure 1 H₂S gas detector was mounted at height.

During the survey, it was noted that several of the H₂S gas detectors were mounted at position which was a considerable distance away from deck level and would not be able to work as per design (Figure 1). Some were also noted to be with error / warning messages displayed. It was recommended that the H₂S gas detectors are installed close to deck for proper detection as H₂S is heavier than air. (Refer to IMO 2009 MODU Code section 9.12.1) Also, ensure that the rig fire and gas detection is part of the rig PMS. All detection systems along with sensors/detectors shall be identified, tasks specified, and the time intervals between tests stated.

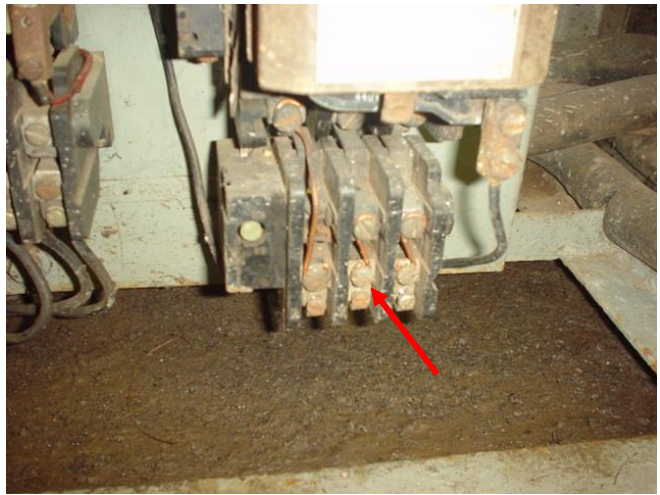
Figure 2 Thermal overload protection element of this circuit breaker was bypassed with big copper wires.

There was a circuit breaker inside the main switchboard where its thermal overload protection element was bypassed with big copper wires. This is a potential fire hazard and the overload relay should be replaced immediately. (Refer to IMO 2009 MODU Code section 5.6.13) It was also recommended to ensure that circuit breakers and thermal overloads are tested through current injection test periodically. (Refer to IEEE 242 sections 16.5 to 16.15; NFPA 70B chapter 11; AS/NZS 3019:2007 Section 2.8/5.6/5.8)
