Safety Awareness Topic of the Month

Electrical Safety

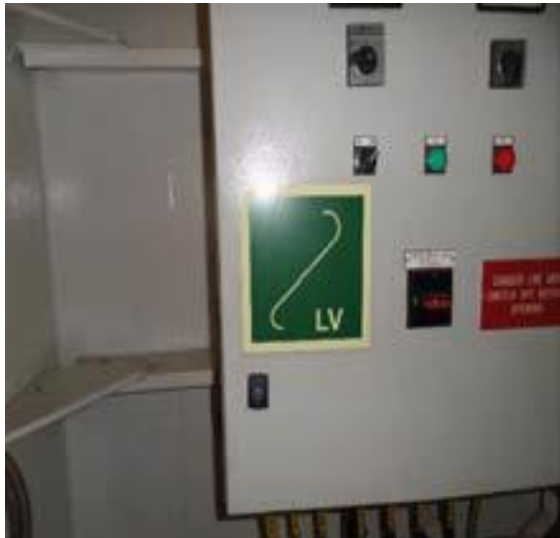
Figure 1: Shows the location where the rescue hook should be.

Whilst carrying out a check on electrical items, it was noted that several rescue hooks were missing. This hook is used to assist in the rescue of personnel by dragging them away from the source of electrocution.

It is important that preventive maintenance systems promote regular inspections of safety equipment points, particularly relating to rescue equipment. It is also recommended that these checks are added to regular equipment checks.

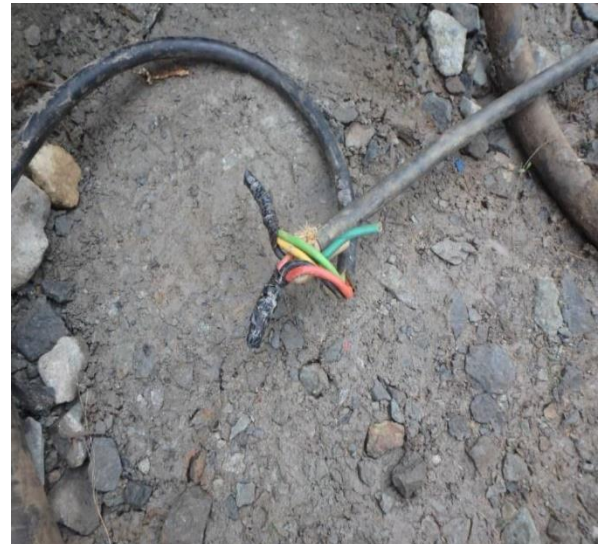
Figure 2: Cable terminations / entries with sheathing cut short, and splices with only electrical tape, including cable repairs using electrical tape.

Appropriate approved cable joining should be used at all times, or the cable replaced. AS/NZ3000:2007
