Safety Awareness Topic of the Month

Choke and Kill Systems – Target Blocks/Fittings

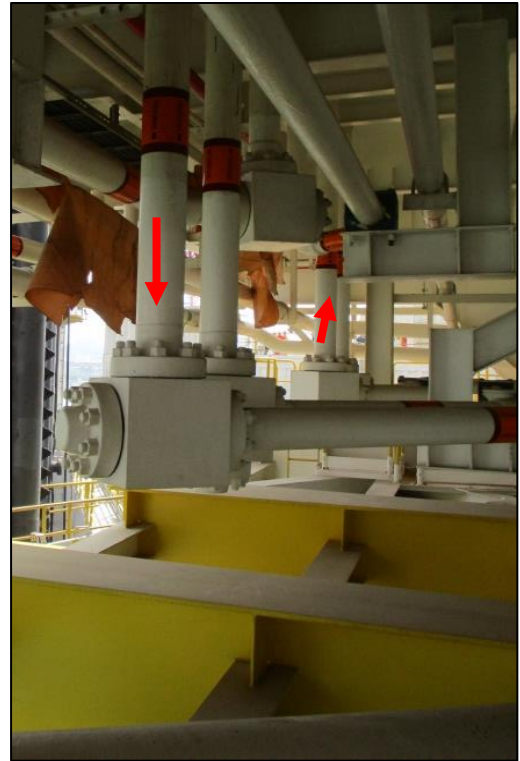
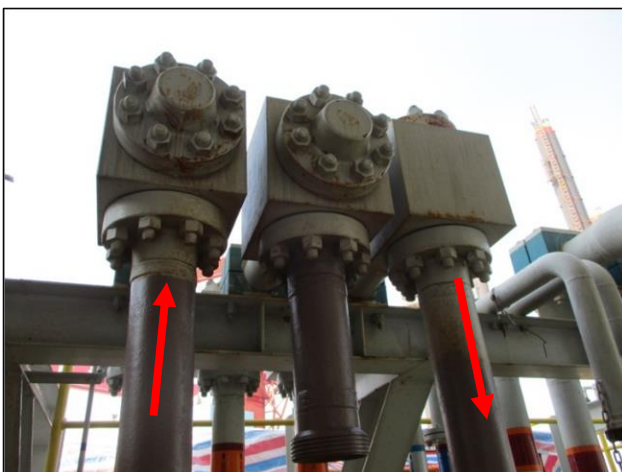
At the time of a recent selection survey for a new-build rig, the ModuResources' Surveyors noted that some of the 90-degree target blocks for the rig's choke and kill system had been incorrectly installed, with respect to flow direction.

In this instance, the approved P&IDs were reviewed, flow direction traced and confirmed, and the Client notified of the error and assistance requested to address prior to mobilization of the rig.

In this case, a relatively simple fix in the shipyard, that would have been more difficult to complete offshore.
